AMERICAN FIRE LOSS ANALYSIS Inc.

ASSIGNMENT:

The assignment to conduct an origin and cause investigation was received on April 4, 2022, from Martin Durkin Esq. of Durkin Law Offices P.C. The fire to be investigated occurred on December 14, 2017, at the commercial structure located at 1-3 West Independence St. Shamokin, PA 17872. The fire was reported to emergency services by Victoria Eckbold at 0134 hrs. This investigation was completed using the provided photographs, reports, and depositions along with a physical site visit, and interviews.

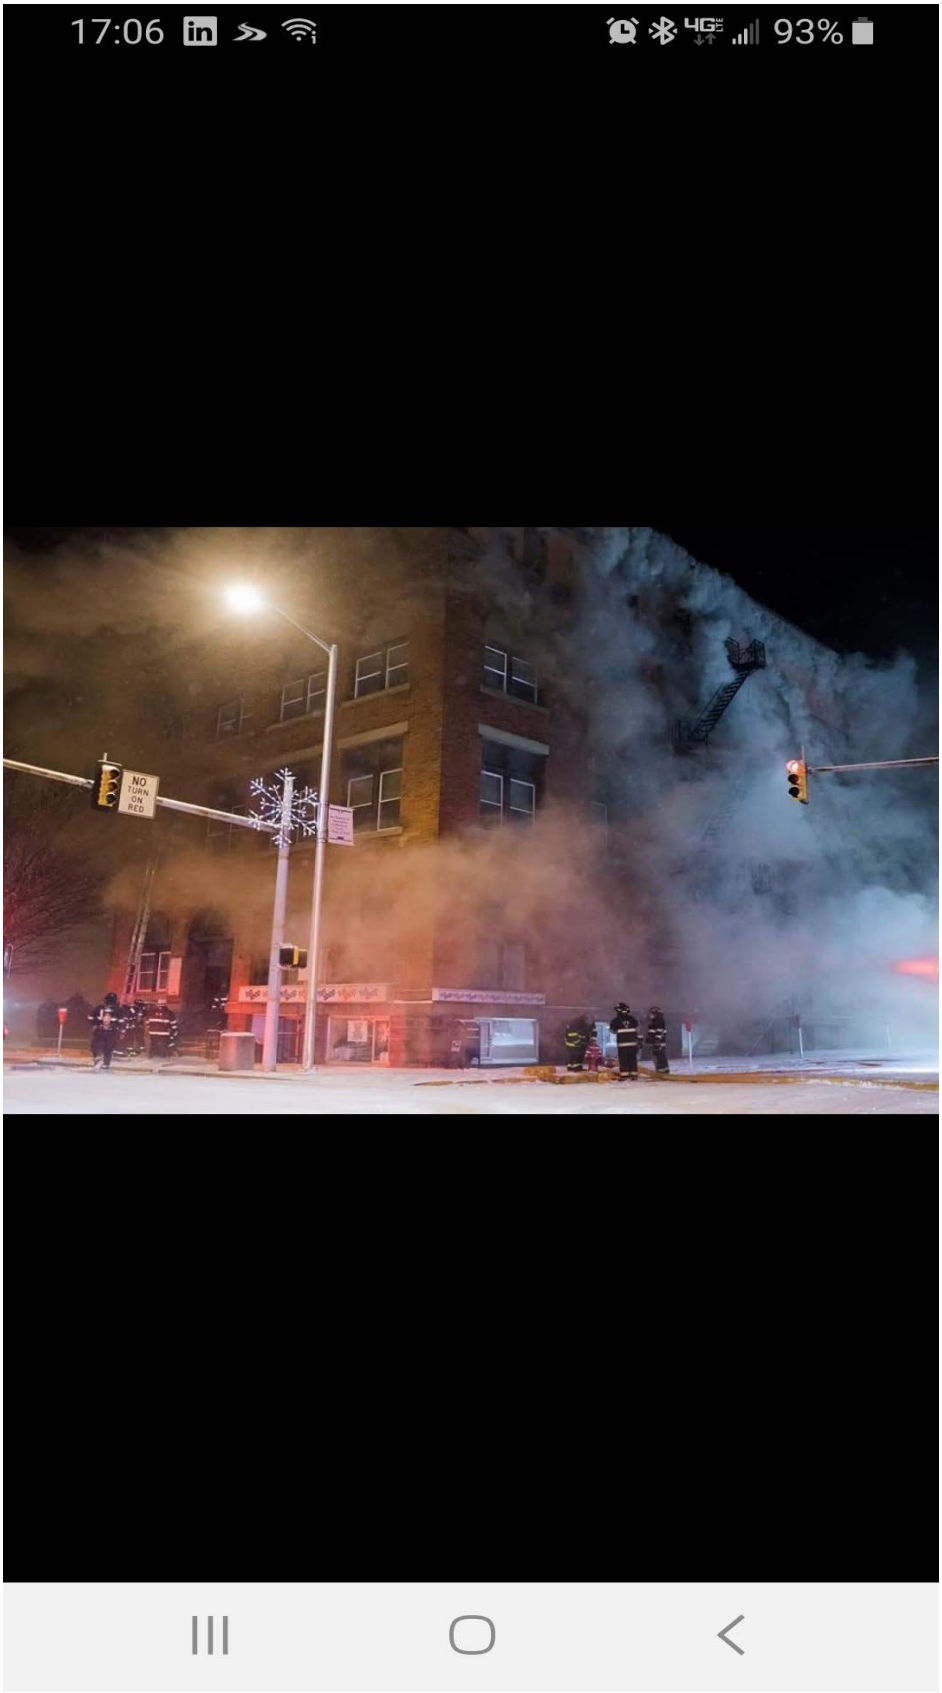
Side “A” (front) of 1-3 East Independence St. Shamokin, PA 17872
